<b>APDES INSPECTION REPORT</b> Alaska Department of Environmental Conservation Division of Water 610 University Ave, Fairbanks, AK 99709				ADEC APDES Inspection Form Last updated (4/08)
					Phone: (907) 451-2298 Fax: (907) 451-2187
Section A: General Data					
Inspection Date	Permit #	Facility Type	Receiving Waters	Weather	Borough
2/1/10 - 2/2/10	AKR05CC38 WPC 900.44.002	Stormwater MSGP	Resurrection Bay	Current Conditions: 18°F 0 Days since last snowfall >0.1 inches:	Kenai Peninsula
Discharges to: Surface Water <input checked="" type="checkbox"/> Ground Water <input type="checkbox"/>				<b>ANNOUNCED</b> Inspection	
Section B: Facility Data					
Name and Location of Site/Facility Inspected			Entry Time	Permit Effective Date	
Aurora Energy Services, LLC 903 Port Ave., Seward, AK 99664			Loc:		Feb. 26, 2009
			Lat: 60.1222° Long: 149.4335°		
			Exit Time		Permit Expiration Date
			2/1 1700 hrs 2/2 1200 hrs		Sept. 29, 2013

# **PHOTO ADDENDUM – AURORA ENERGY SERVICES, LLC: 2/1&2/10**

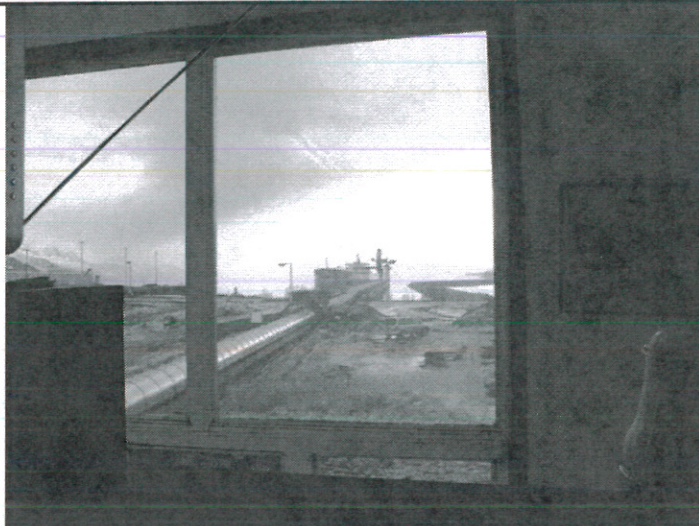
**IMAGE 5: VIEW FROM CONTROL ROOM LOOKING SOUTH TOWARD THE SHIP LOADER**

- The control room windows provide good views (Images 5 & 6) of the conveyor coming from the stacker/reclaimer and to the ship loader.
- Upper and lower sprayer bars were operating on the stacker/reclaimer (Image 9) as it reclaimed coal from the pile. No dust was observed to be generated.

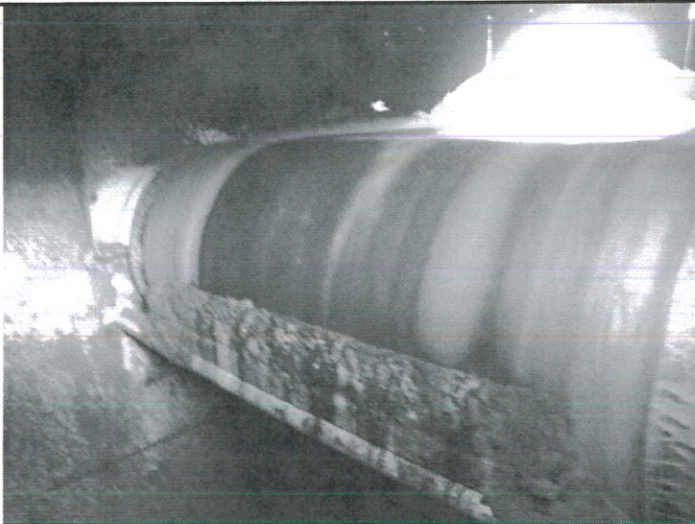
- Scrapers were being employed to remove coal dust from sections of belt conveyor in various locations (Images 10-11)
- Several sprinkler heads were situated along the east berm next to the coal piles (Image 12).

**IMAGE 10:** Primary scraper inside housing at corner of BC-12 and BC-13

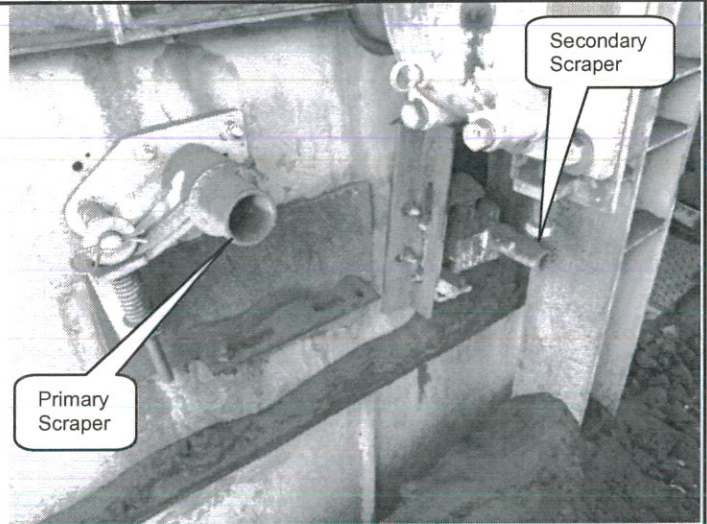
**IMAGE 11:** BC-12/BC-13 primary & secondary scrapers (view from housing exterior)

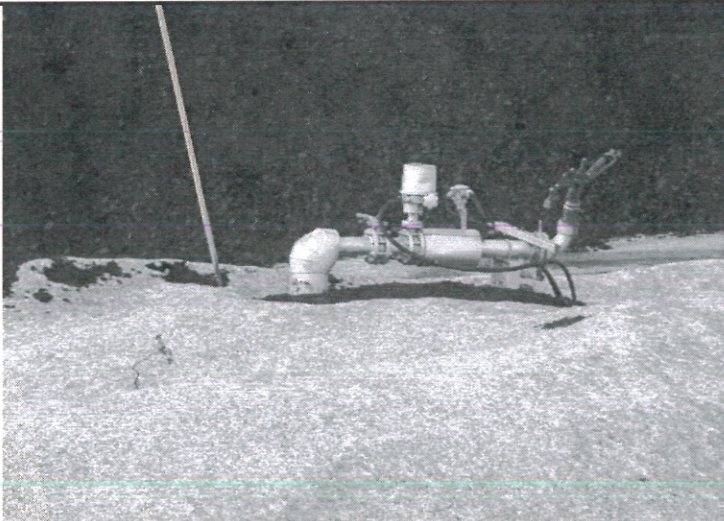
**IMAGE 12:** One of several sprinklers on east side of coal piles

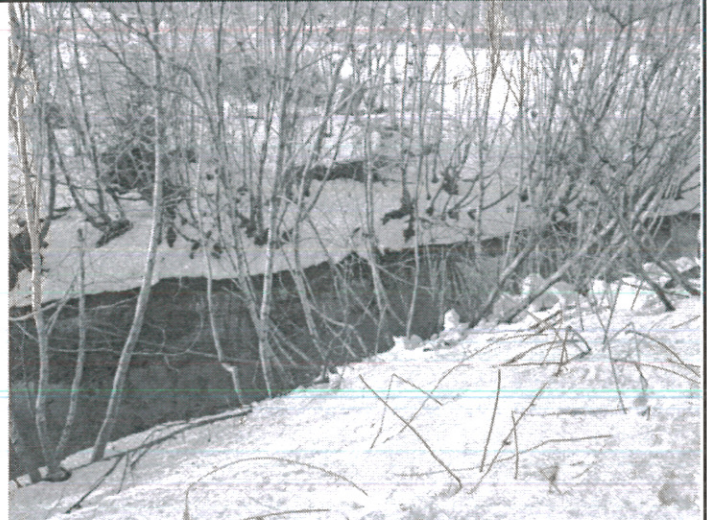
- Control structures (vegetated berms, RR grade and silt fence) served to surround the site on all four sides (Images 13-17)
- A water filled ditch located outside (on the city side) of the site's west berm (Image 13) appears to receive drainage from a pond which is located outside the site's north berm, and from several other business' located between the highway and the coal loading facility.

**IMAGE 15:** Drainage ditch located outside (City side) of the site's west berm.

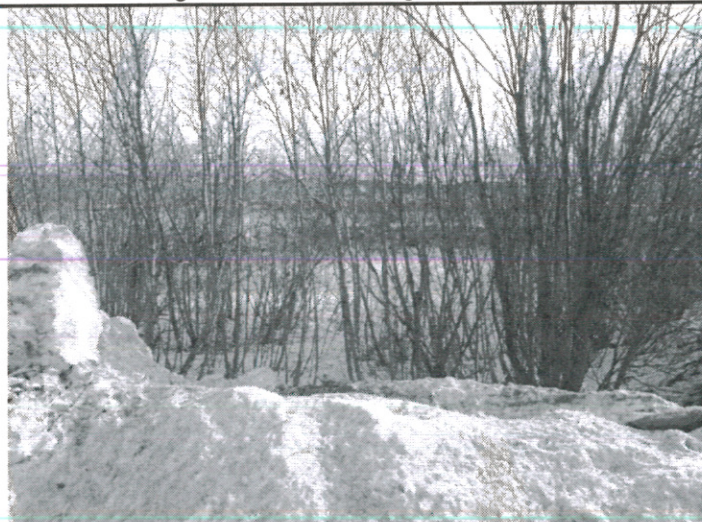
- Both settling ponds were frozen over (Images 18-19).

**IMAGE 18:** West settling pond (looking N)

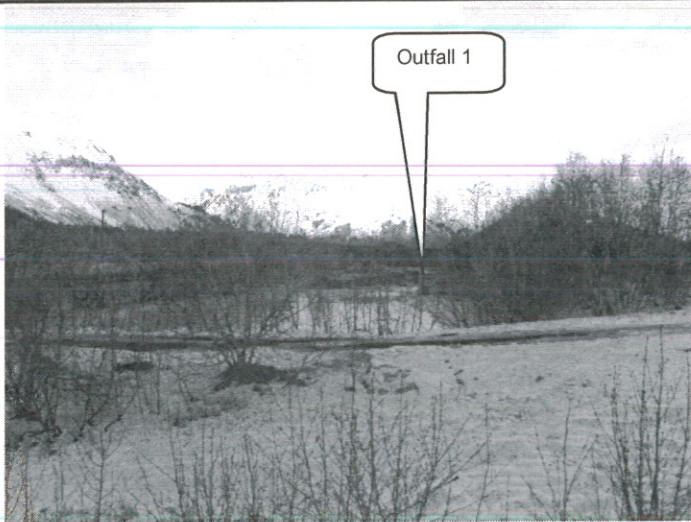
**IMAGE 19:** East settling pond & Outfall 1 (looking N)

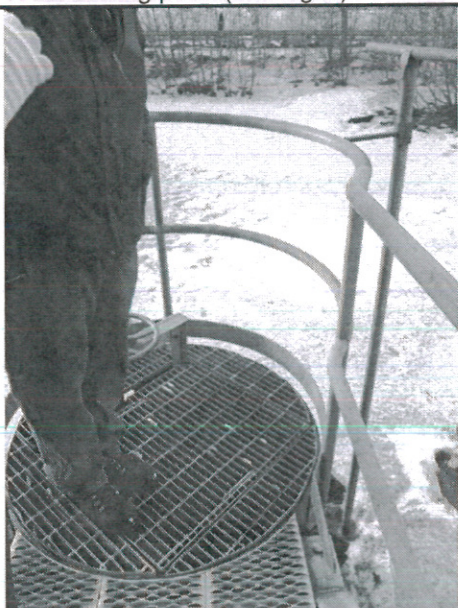
**IMAGE 20:** Outfall 1

- Water could be heard flowing at Outfall 1 (Image 20).
- Outfall 2 (Image 22) was surrounded by a gravel filter, and Outfall 3 (Image 21) was covered with a fabric filter and surrounded by gravel.

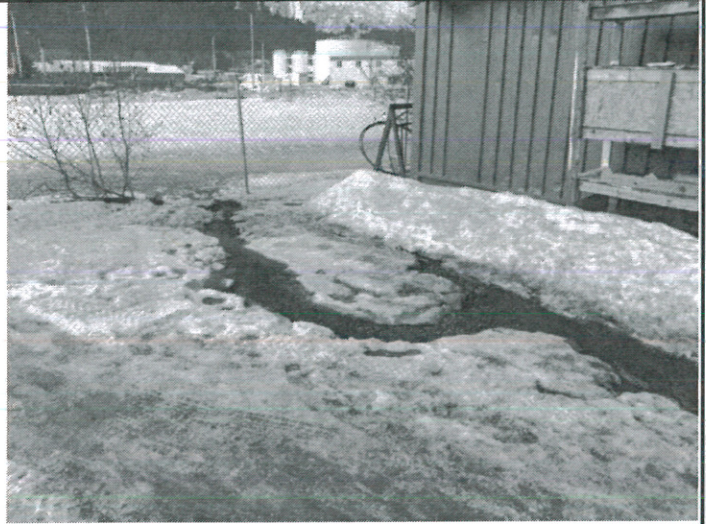
IMAGE 23: Outfall 4

- Outfall 4 (Image 21) was the only area where signs of recent run-off were observed. This outfall can be characterized as a gravel road surface leading to the water-filled, vegetated ditch described in the previous paragraph.

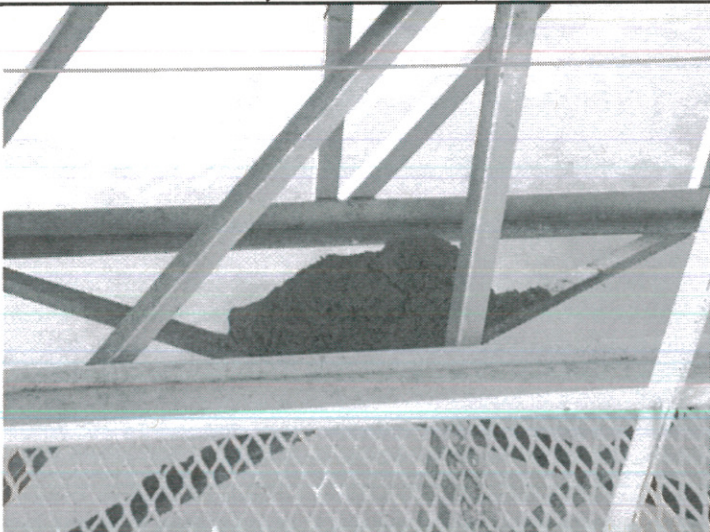
4. Outfall 4: 60°07'334"N, 149°25'.755"W
- Day 1 Tour (a few hours after the commencement of coal transfer, and at an average of 800 tons/hour): The dock alongside the conveyor was coated with coal dust, but there was not many coal chunks. An accumulation of coal dust was observed on the structure below the conveyor (Image 26). No visible dust was being generated at the end of the loading process and no coal debris was observed falling into the Bay.

- Dust accumulates on and below equipment, and flakes of "carry-back" were observed dropping into Resurrection Bay.
- Spilled coal was observed accumulating on the dock below the ship loader and on structural components under the belt conveyor next to the dock.
- Benchmark monitoring results exceeded benchmark parameters for Total Iron and Total Suspended Solids.

IMAGE 26: Day 1 - coal dust on cross-brace below conveyor

1. Industry research – Conduct research to determine if any additional control measures exist in similar industries, which might be implemented to further reduce carry-back and the spillage of coal during the transfer process.

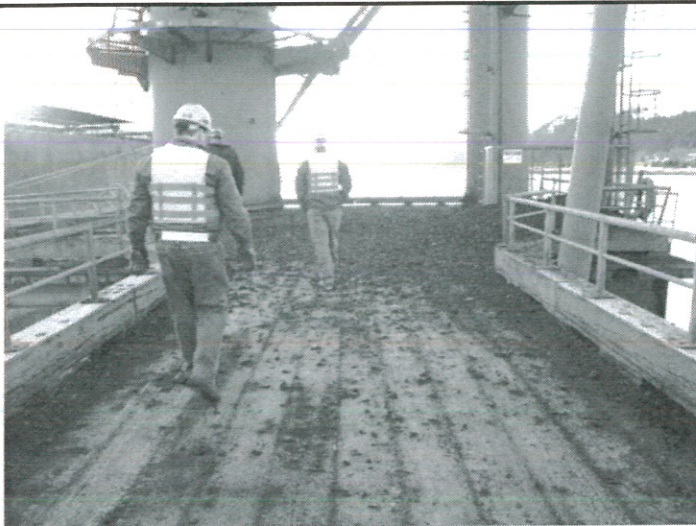
- Day 2 Tour (almost 24 hours after the commencement of coal transfer, and at an average of 900+ tons/hour) : Coal dust and chunks had accumulated on the dock below the ship loader and the conveyor catwalk near the ship loader (Images 28-29). No chunks of coal were observed falling into the water but flakes of "carry-back" (congealed coal dust) were observed falling from the conveyor near the ship loader, and from the ship loader itself, into the Bay (Image 31). No visible dust was being generated at the end of the ship loading process, but dust was visible on the ship's deck and hold cover (Image 33).

**IMAGE 28:** Day 2 - Loose coal on dock below ship loader

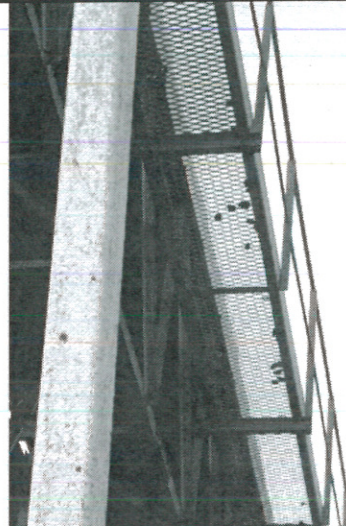
**IMAGE 29:** Coal on conveyor catwalk near ship loader

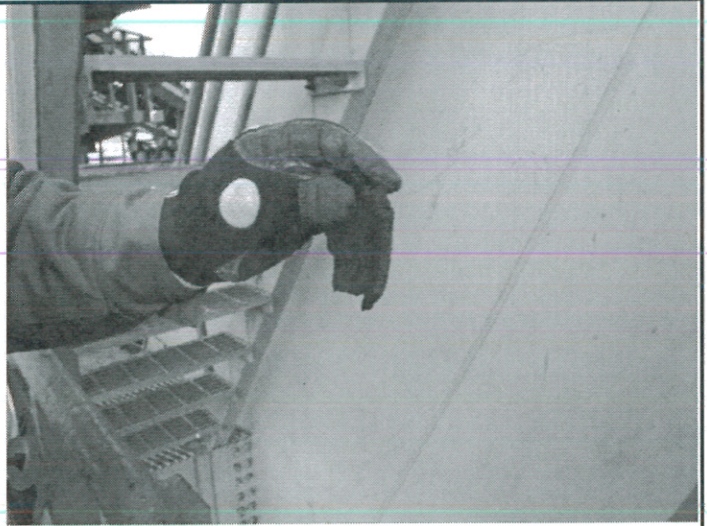
**IMAGE 31:** Flake of "Carry-back" from conveyor belt

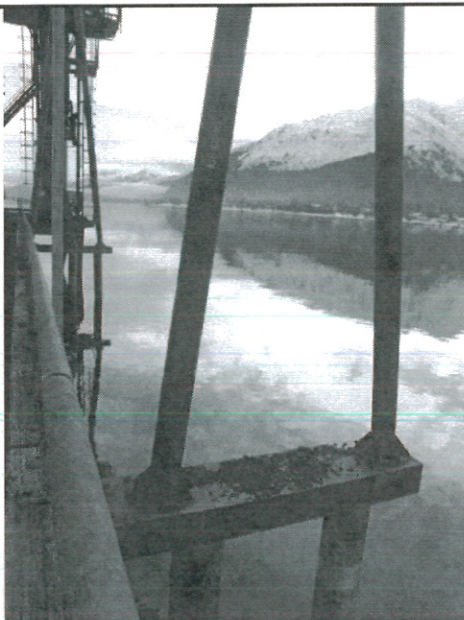
**IMAGE 32:** Coal below conveyor next to ship loader

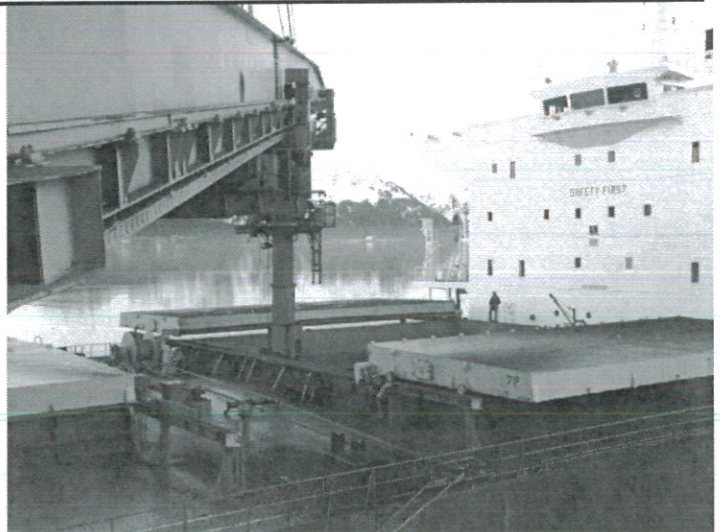
**IMAGE 33:** End of loader inside hold & dust on deck

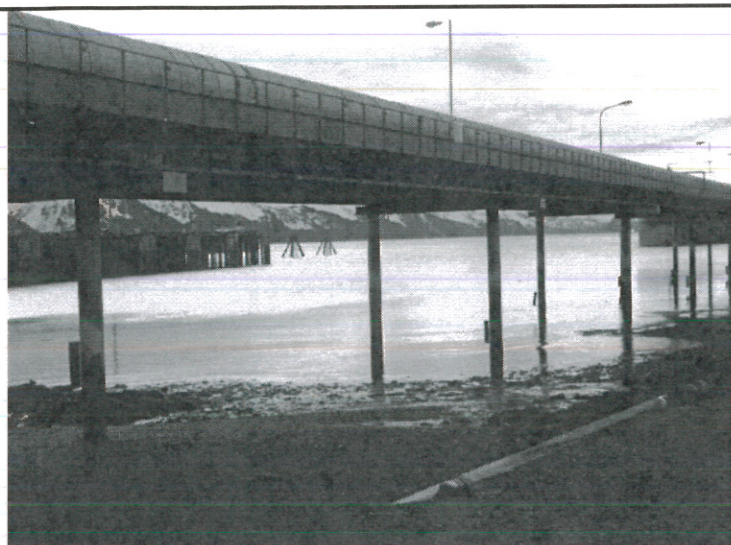
Finally, on Day 2 (just prior to the second tour) Inspector Speckman walked the beach area just south of the south end of the facility, below the belt conveyor leading out to the ship. During this walk (which occurred at low tide) no dust or coal was observed on the beach, and no coal or coal debris was observed falling from the conveyor (Images 34 & 35).

IMAGE 34: Day 2 - beach below conveyor

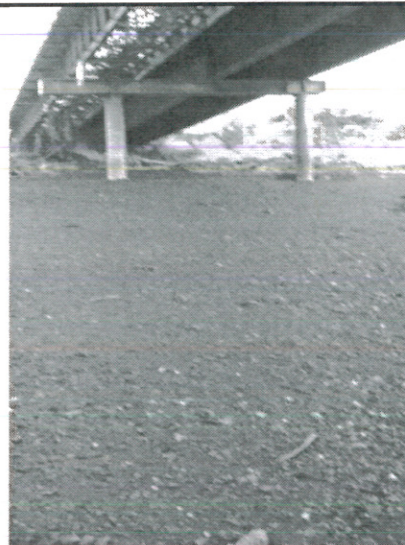
IMAGE 35: Beach below conveyor - low tide
